Demonstration and Validation of Reactive Vitreous Coatings to Prevent Corrosion of Steel Fixtures Attached to Masonry Walls

Final Report on Project F10-AR12

Under Project F10-AR12, "Use of Reactive Vitreous Coatings on Steel Fixtures for
Masonry Wall to Prevent Corrosion at Fort Stewart, GA"

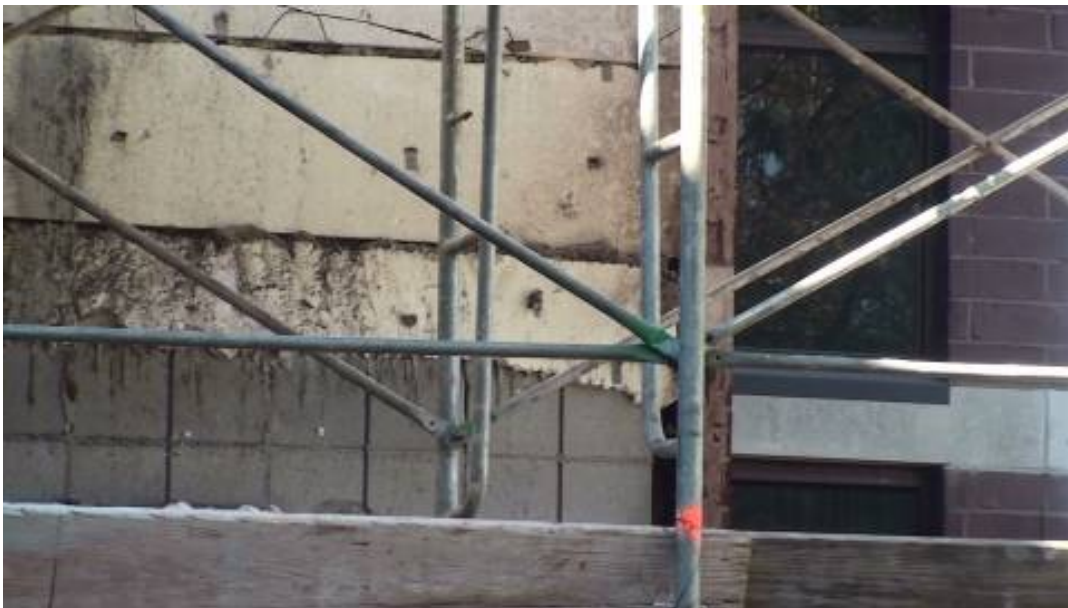
Figure 5. Selected panels stripped to bare walls.

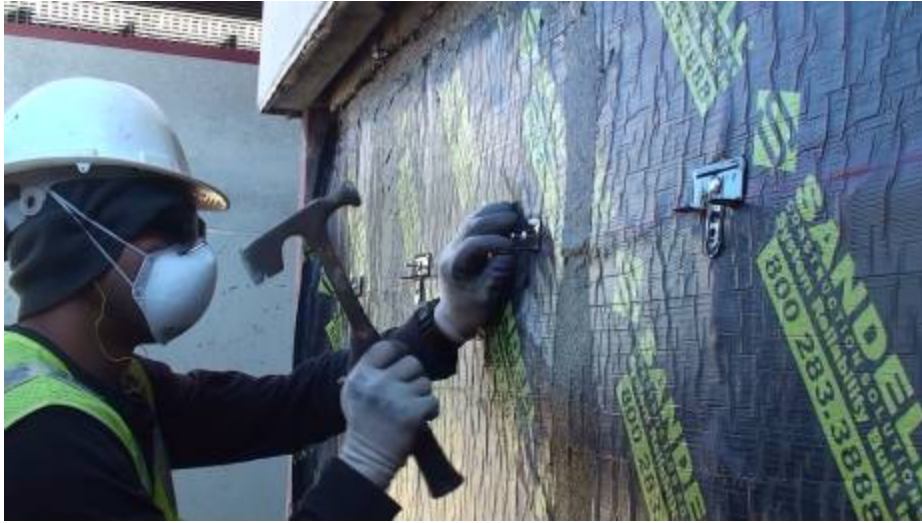
Figure 10. Installation of a double-eye wall tie component.

Inspection results indicate that the demonstrated coating is very brittle, like a typical ceramic or glass material. Therefore, the coating is vulnerable to fracture when the treated hardware is bent or subject to sharp impact. Although conventional steel ties and pintles tolerate bending adjustments and impacts related to shipping, handling, and installation, the coating on the demonstrated enameled hardware is subject to damage from such stresses. The wall ties in particular are subject to sharp impacts associated with the installation process, which uses hammer-driven pin anchors as described in section 2.2, Figure 10; the impact of hammering can potentially cause damage to the coating.

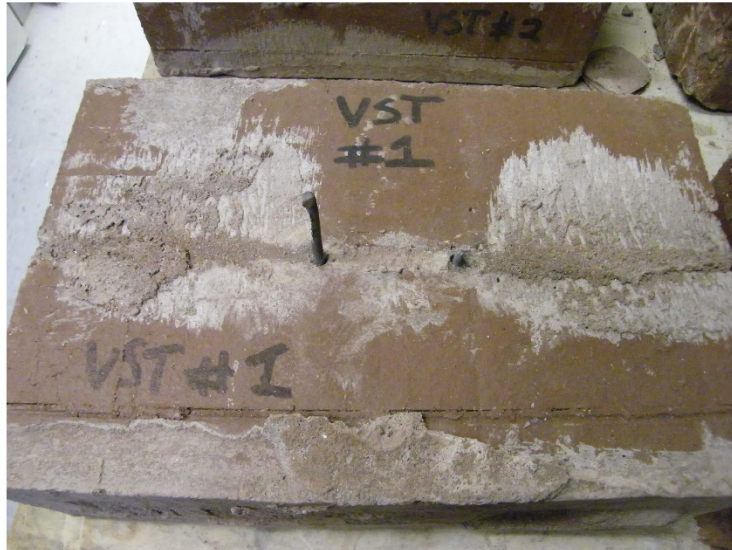
Photo 2 – Mode of Failure – VST #1

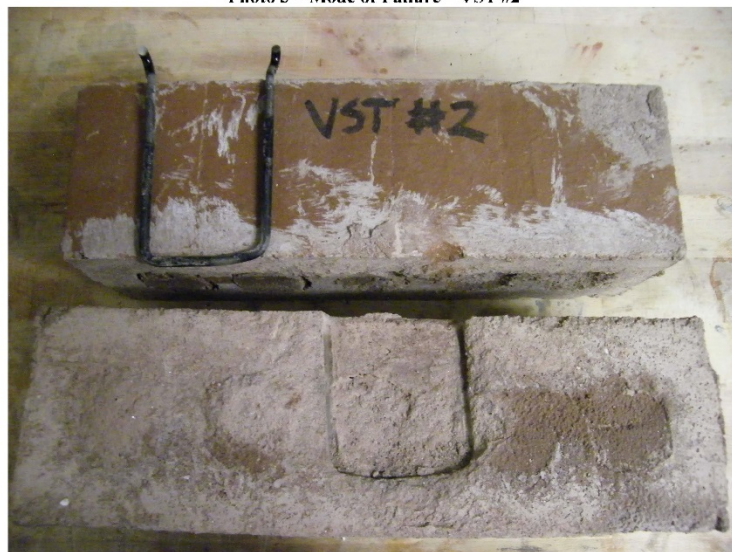
Photo 3 – Mode of Failure – VST #2

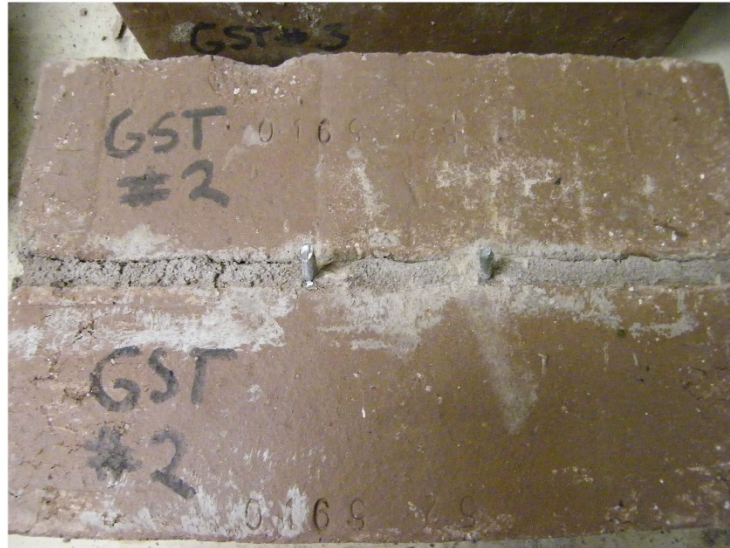
Photo 6 – Mode of Failure – GST #2

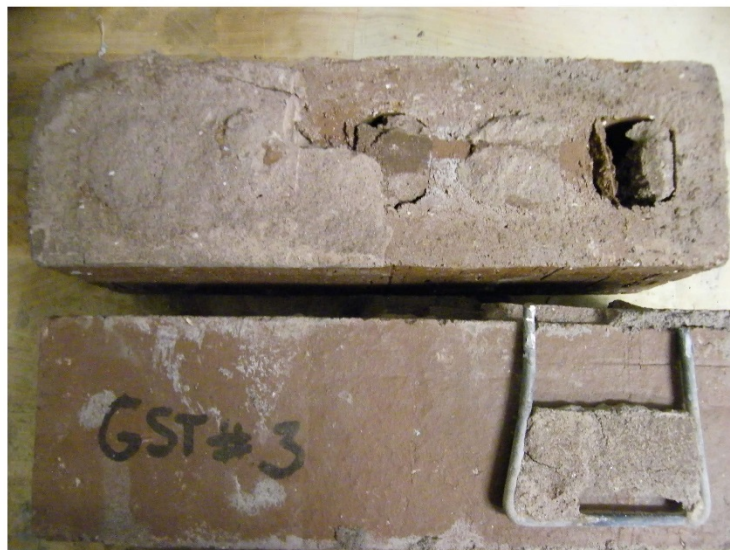
Photo 7 – Mode of Failure – GST #3

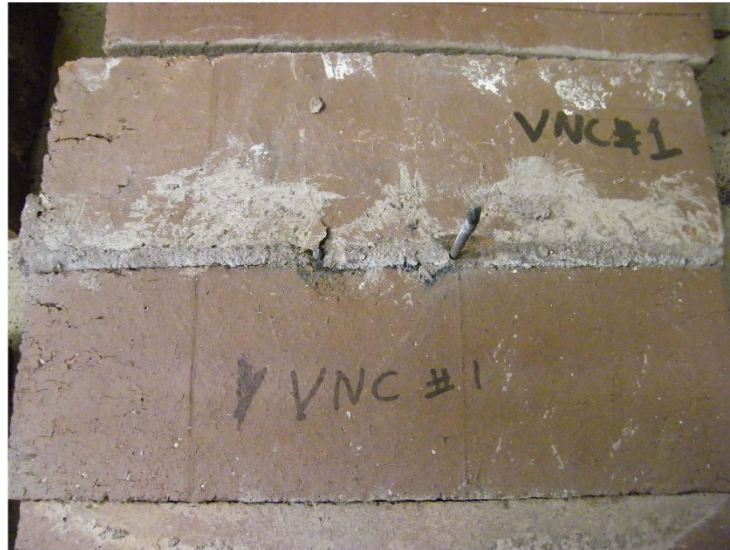
Photo 8 – Mode of Failure – VNC #1

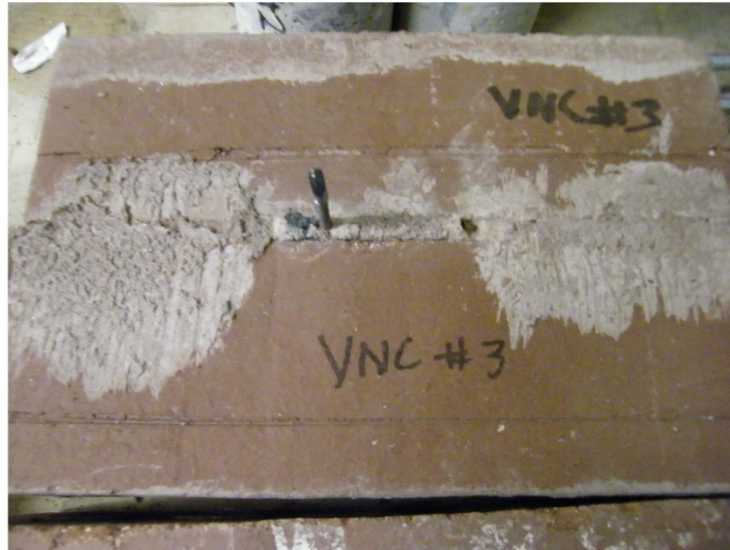
Photo 10 – Mode of Failure – VNC #3

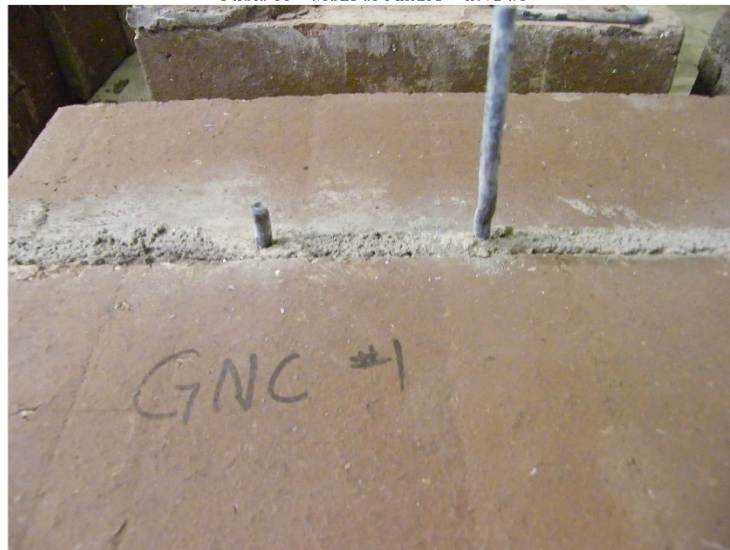
Photo 11 – Mode of Failure – GNC #1

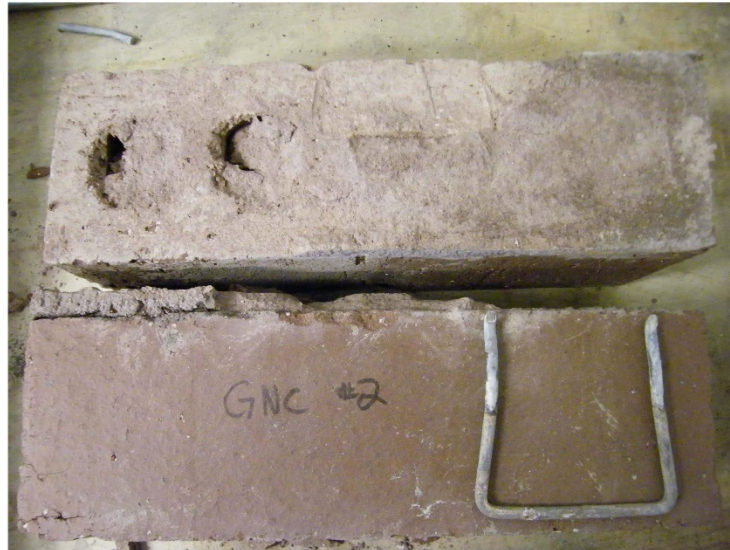
Photo 12 – Mode of Failure – GNC #2

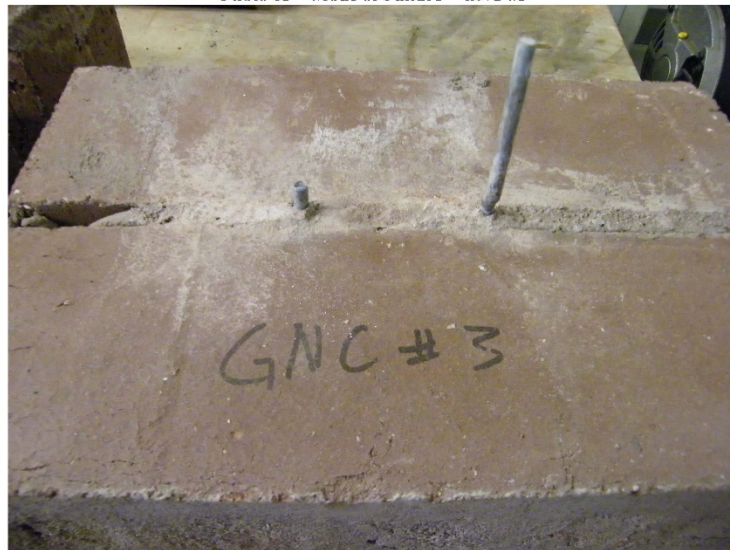
Photo 13 – Mode of Failure – GNC #3

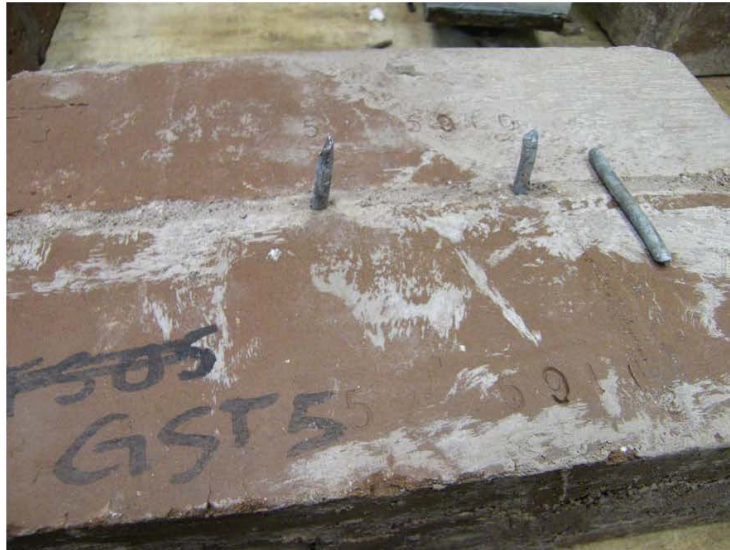
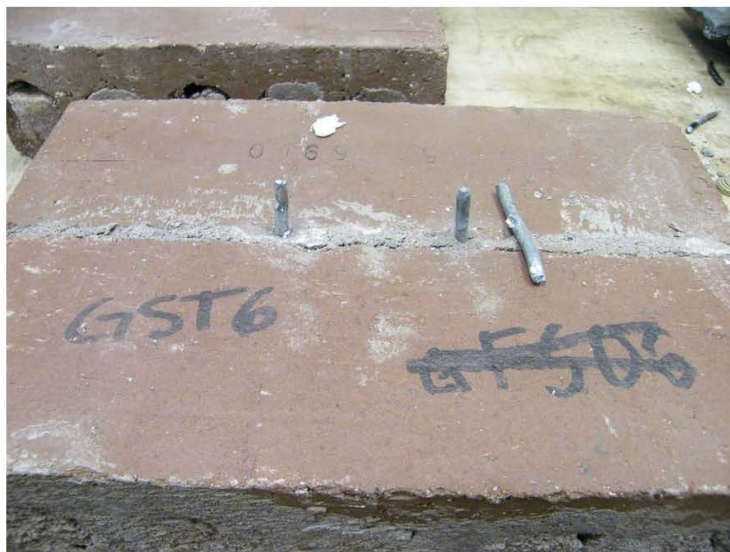
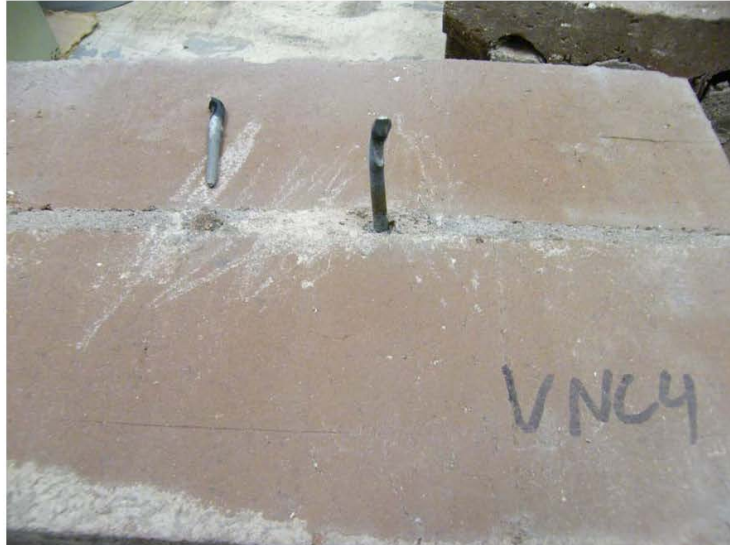
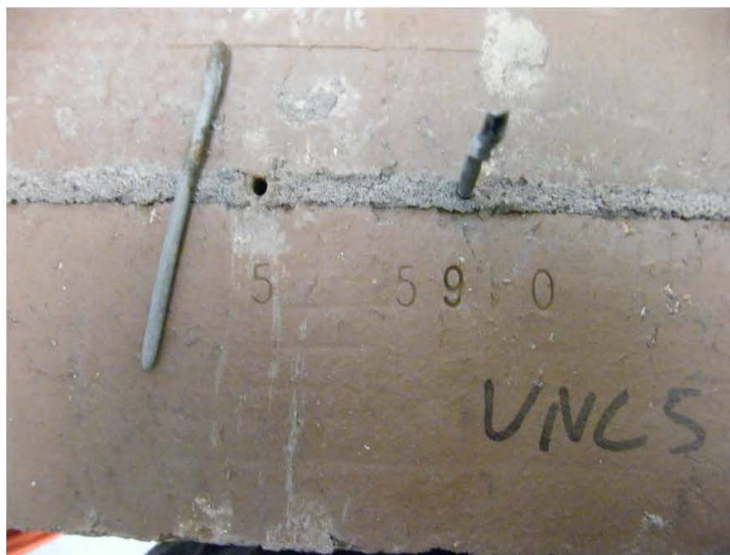
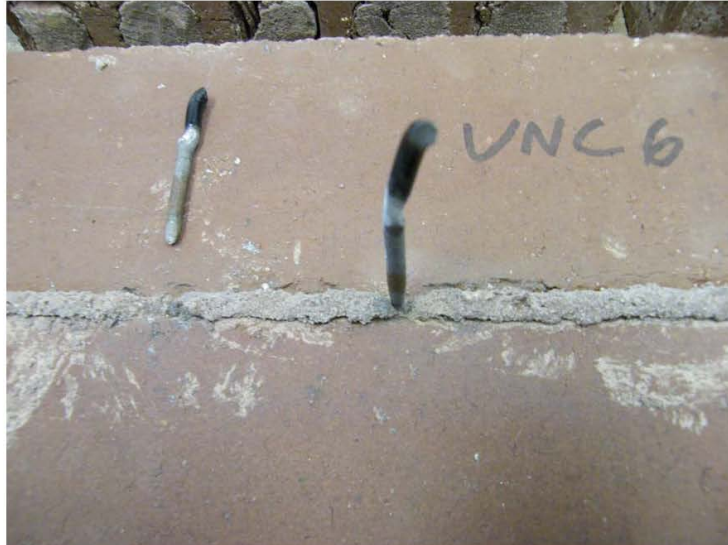
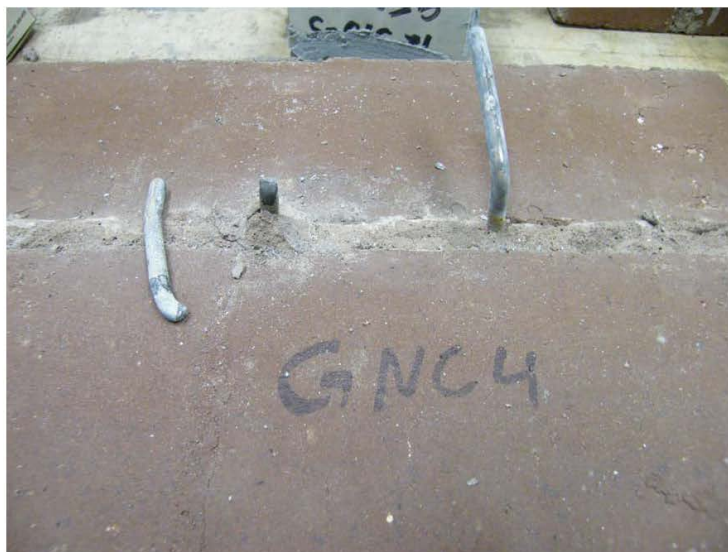
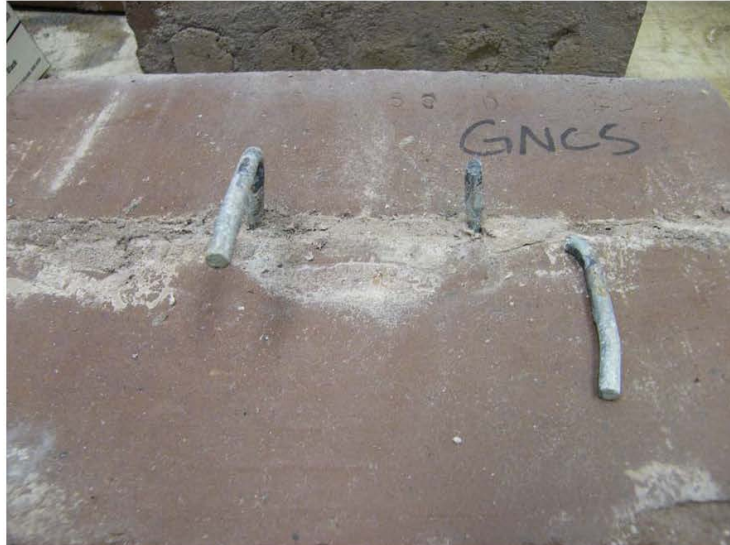
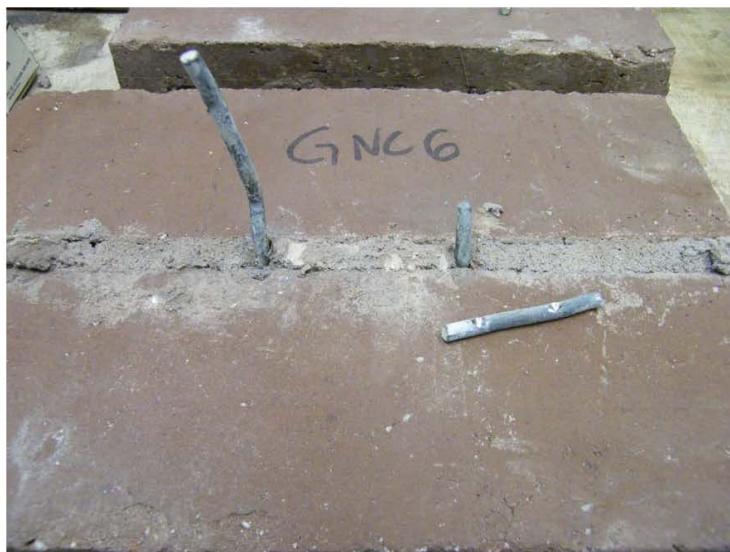
Photos of Failure Modes

Photos of the test samples before and after testing are attached to this report. Load vs. displacement curves for each specimen are also attached to this report. It was observed that the thickness of the mortar joints and the depth of the tie placement varied amongst the samples.

Sample ID	Peak Load (lbs)	Displacement at Peak Load (in)	Failure Type
VST 4	2,132	0.4715	One sided Metal Tensile Failure
VST 5	2,252	0.6225	One sided Metal Tensile Failure
VST 6	2,235	0.7573	One sided Metal Tensile Failure
Average	2,206	0.6171	NA
GST 4	1,575	0.2970	One sided Metal Tensile Failure
GST 5	1,658	0.0930	Double sided Metal Tensile Failure
GST 6	2,487	0.3103	Double sided Metal Tensile Failure
Average	1,907	0.2334	NA
VNC 4	2,238	0.4333	One sided Metal Tensile Failure
VNC 5	2,203	0.7560	One sided Metal Tensile Failure
VNC 6	2,240	0.6395	One sided Metal Tensile Failure
Average	2,227	0.6096	
GNC 4	1,391	0.3703	One sided Metal Tensile Failure
GNC 5	1,752	0.2593	One sided Metal Tensile Failure
GNC 6	1,782	0.2468	One sided Metal Tensile Failure
Average	1,642	0.2921	NA

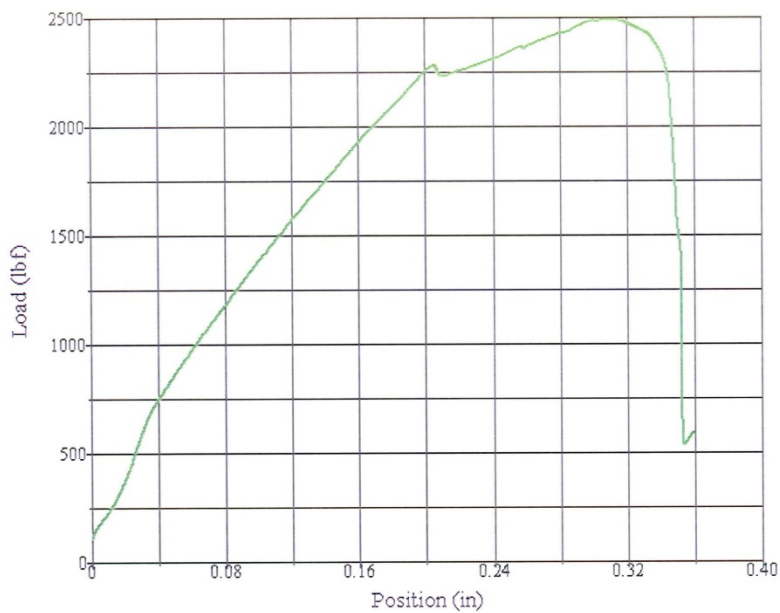
Counter: 9498
Elapsed Time: 00:03:39
Procedure Name: ASTM E754 - Masonry Anchor Pull Out
Start Date: 8/10/2012
Start Time: 10:42:55 AM
End Date: 8/10/2012
End Time: 10:46:34 AM
Workstation: INSTRON2
Tested By: McCants
Specimen Identification: GST 6
Date Made:
